MEADVILLE DAM
CRAWFORD COUNTY, COMMONWEALTH OF PENNSYLVANIA
NDI No. PA 00177
PennDER No. 20-48
SCS No. PA 460

PHASE I INSPECTION REPORT
NATIONAL DAM INSPECTION PROGRAM

MEADVILLE DAM

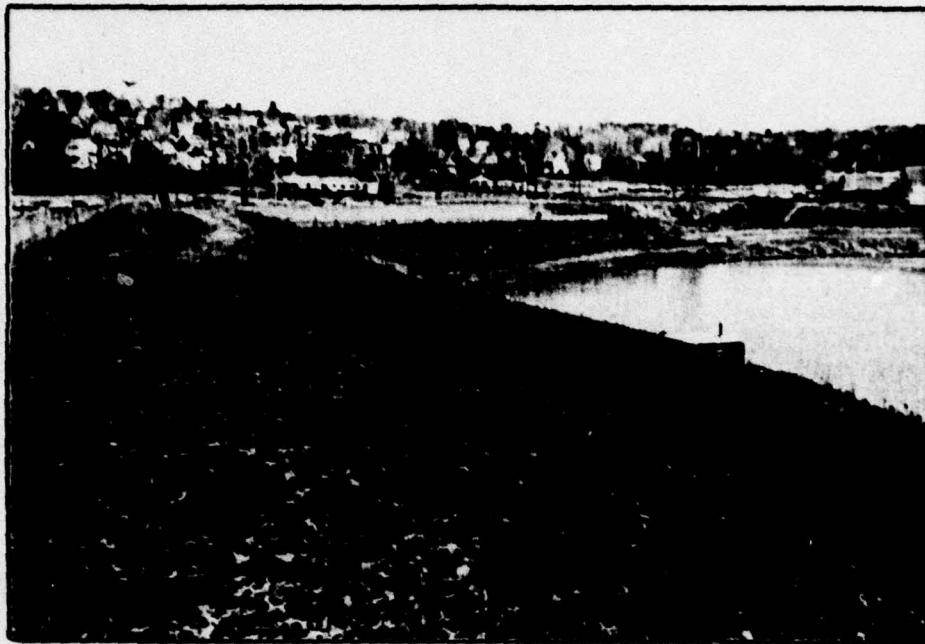
**PHOTO 1. View from Top of Dam Looking East Toward
Auxiliary Spillway and Dike**

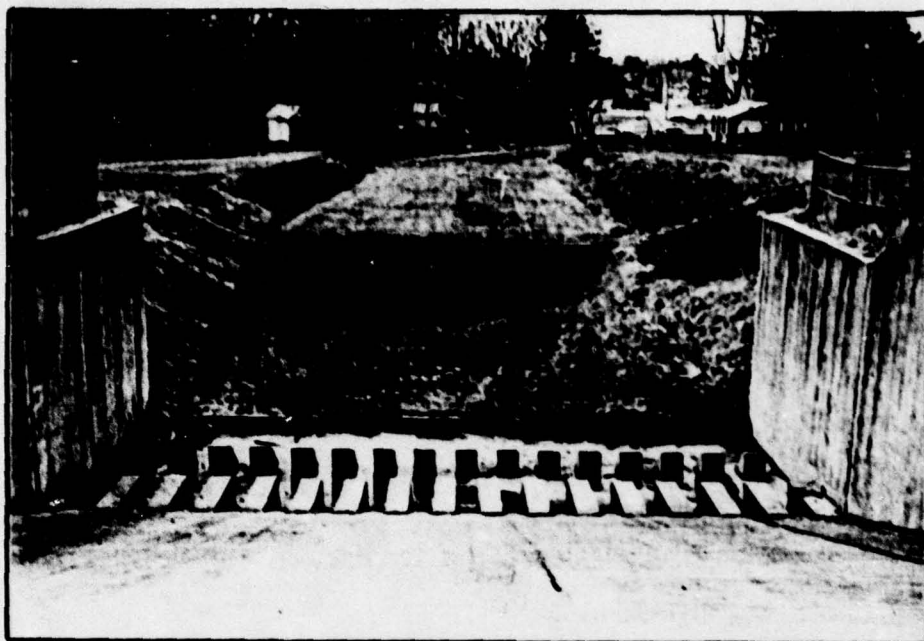
PHOTO 3. View of Grass-Lined Auxillary Spillway Channel from Crest of Ogee Spillway (Note Energy Dissipaters at Bottom of Ogee Spillway)

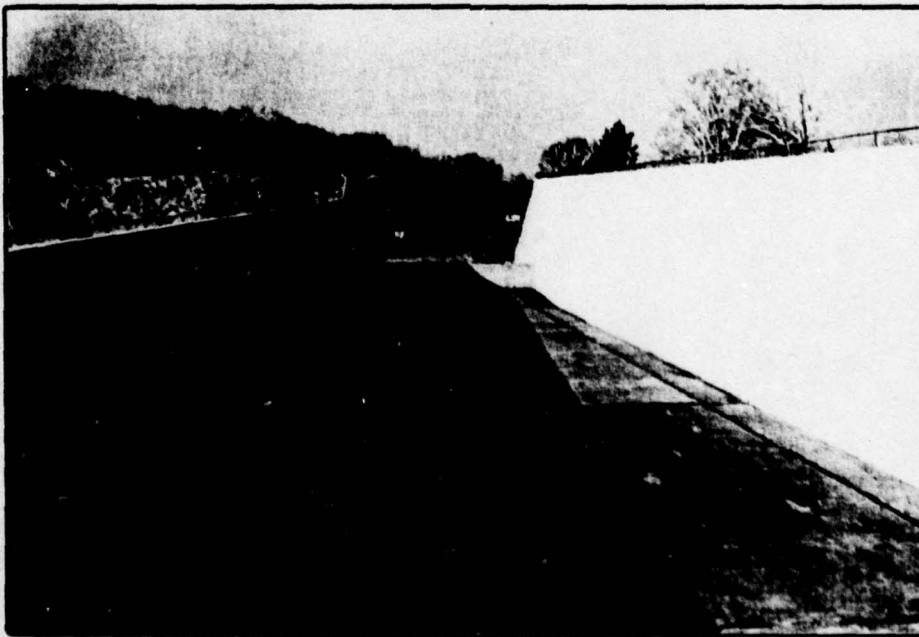
The concrete walls along the auxiliary spillway are in good condition with the exception of some minor spalling along the outside of the south end wall. Some cracks were also noted on the walls adjacent to the spillway. The differential movement of the walls and wing walls was noted. According to the local representatives of the city of Meadville, the SCS (designer of the dam) is studying the problem. The movement was first noted in the SCS annual inspection report dated 17 May 1968.

PHOTO 8. Close-up View of South End of Auxilliary Spillway
